# Manhole Inspection Summary

Manhole # S39Y1\_030MH

**Location** Address: **3556 6th St**

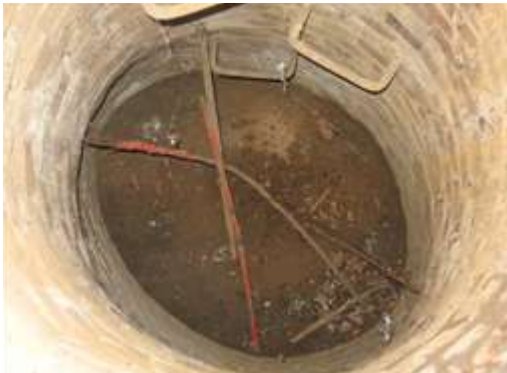
Defect 1

Infiltration: ☐ None ☐ Joint ☐ Cracks ☒ **Mortar** ☐ Roots ☐ Wall

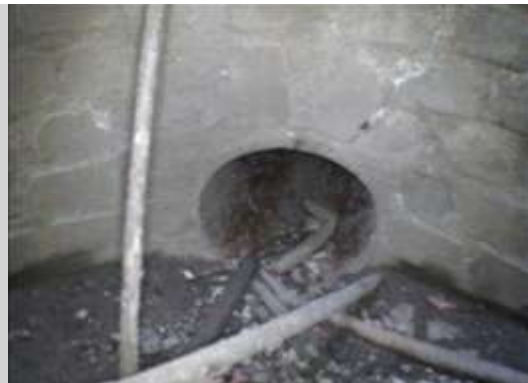
12 O'Clock Outflow

8 in. Circular Gravity Sewer  
Pipe Out @ 12 O'Clock

Infiltration: **None** Pipe Seal Cond: **Sound**
